**Office of Environment, Safety and Health Oversight  
Environment, Safety and Health**

*Type A Accident Investigation  
of the June 21, 2001*

# **Drilling Rig Operator Injury at the Fermi National Accelerator Laboratory**

August 2001

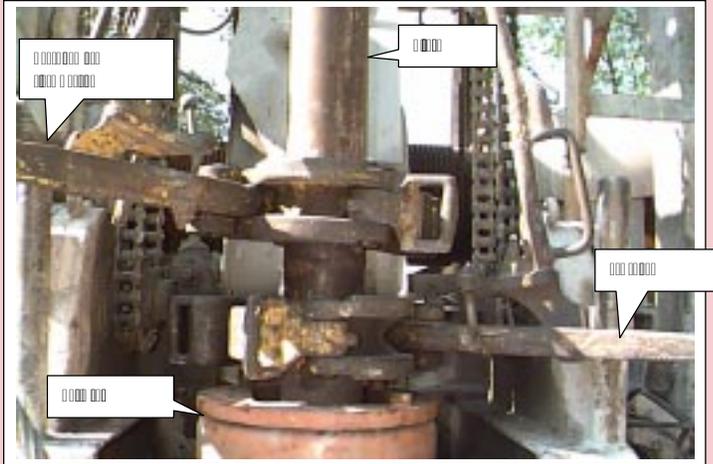
The accident resulted from the failure of the weld connecting the wire rope to the hydraulic cylinder used in making and breaking threaded drill pipe section joints. Torsion is applied to the joints by mechanical tongs (in effect, pipe wrenches) that grip the outer diameter of the drill pipe section. One of the tongs is braced against a drill rig stop pin, while the other tong is operated (i.e., pulled) by a mechanical force supplied by the hydraulic cylinder. This force is transmitted through a wire rope sling connected with miscellaneous hardware.

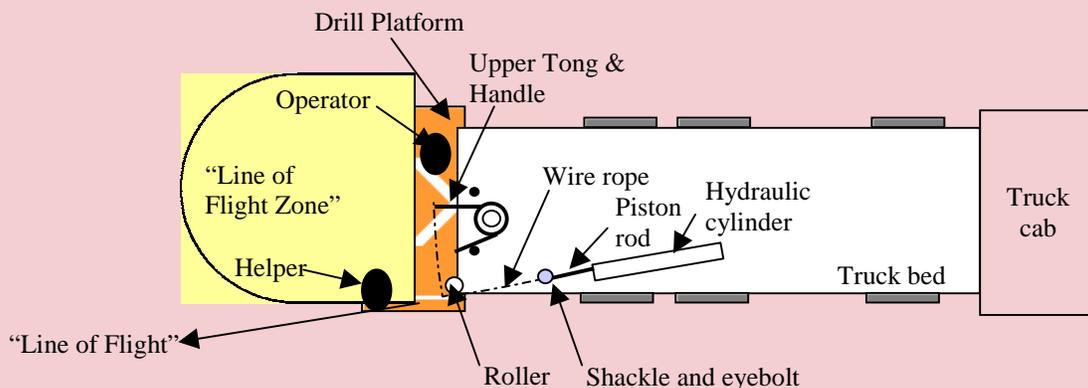
- Combined with the clockwise rotation of the tong handle, this tension release would have jerked the wire rope end (attached to the tong handle) toward the Operator’s location while he was operating the hydraulic controls. This jerk (approximately 2 or 3 feet of tong handle movement) could have propelled the other rope end and shackle and eyebolt within the “line of flight zone” and toward the tong handle. Again, it is unclear how these assumed wire rope motions could have occurred without injuring the Helper.

In summary, based on the Helper’s report of both his and the Operator’s position, and the fact that the Helper was not injured, the wire rope and shackle/eyebolt end did not fly through the “line of flight zone” to strike the Operator. Therefore, the tong handle must have struck the Operator.

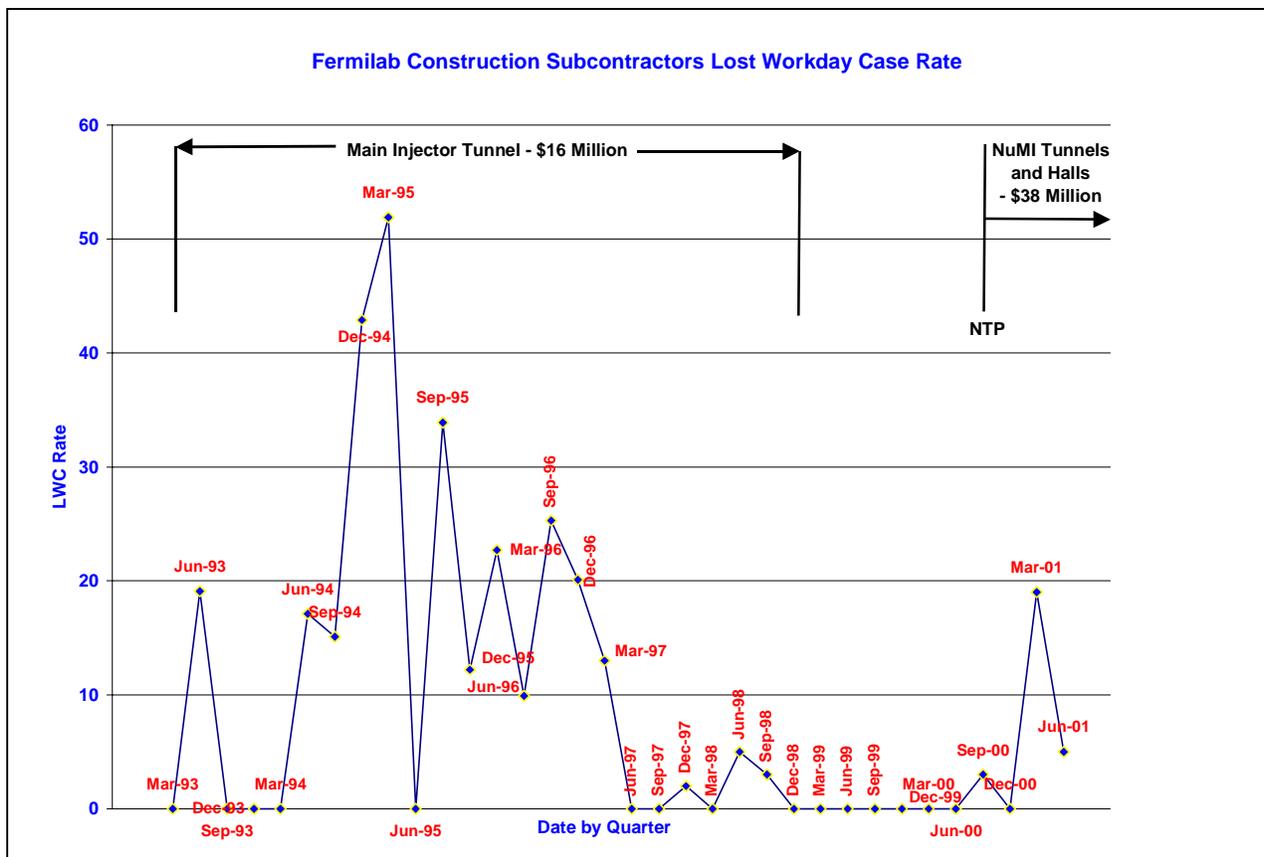
Figure 3-3. Fermilab Construction Subcontractors Lost Workday Case Rate

In addition, the Board evaluated Fermilab Construction Subcontractor Lost Workday Case rates to identify reporting and construction trends associated with this data. The Board used CAIRS Lost Workday Case rates from March 1993 to June 2001. This time period includes construction of Fermilab's two major tunneling projects, the Main Injector Tunnel and NuMI Tunnels and Halls. The Board compared the Lost Workday Case rate information for Fermilab Construction Subcontractors provided to the Board during the inbriefing to Lost Workday Case rate information in CAIRS for the period August 27, 1998, to September 15, 2000. Although Fermilab data shows 750 days without a lost workday case during this time period, the Board identified that a subcontractor pipe fitter dislocated his shoulder on November 11, 1998, resulting in 6 lost workdays. Additionally, for six months during the same period of time, Fermilab did not perform any fixed price construction work, thus minimizing the possibility that a lost workday case would have been experienced by subcontractors. Finally, a review of Lost Workday Case rates for the first six months of construction activities on each tunneling project indicated the Lost Workday Case rate approached 20 during the initial phases of construction as shown in Figure 3-3.

*The Board concluded that Fermilab had not consistently and effectively reported accident and injury information pertaining to construction subcontractors into CAIRS.*
